NASA
Technical Memorandum 4195

Evaluation of Composite Components on the Bell 206L and Sikorsky S-76 Helicopters

Donald J. Baker
Aerostructures Directorate
USAARTA-AVSCOM
Langley Research Center
Hampton, Virginia

1990

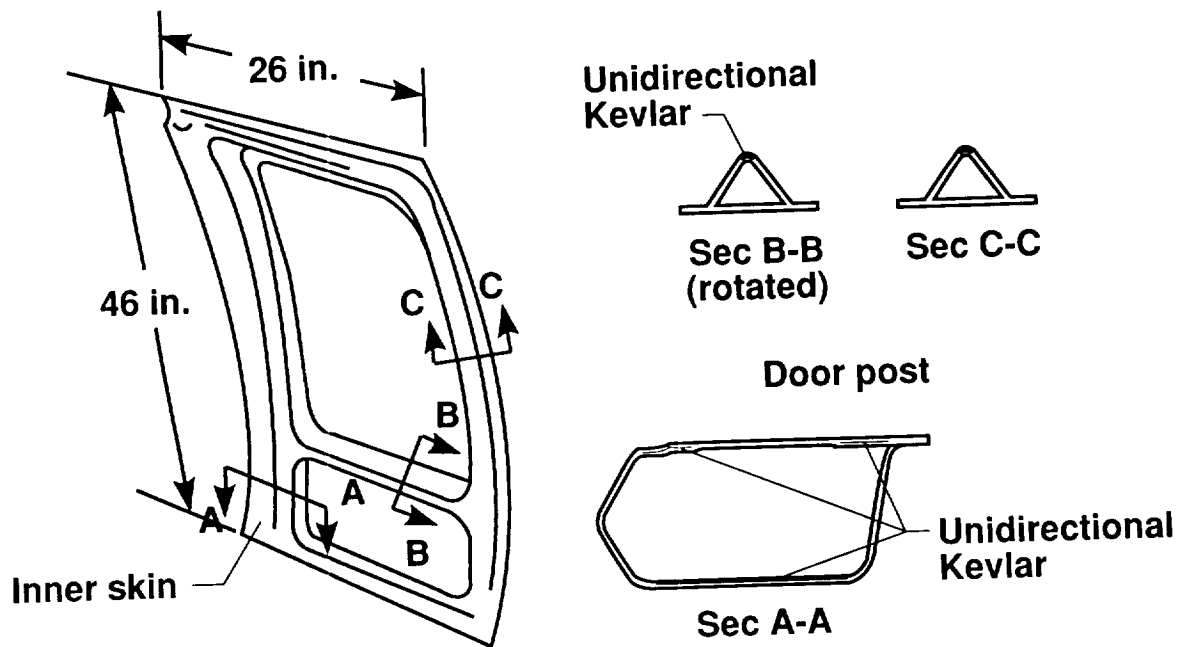
Figure 2. Bell 206L Kevlar/epoxy litter door.

The litter door has had very few problems with the composite material skins. However, a major problem occurred with the metal hinges that are used to hold the cabin door. The hinges were under-designed and failed in service when someone pushed the cabin door open too far. New high-strength hinges have been installed and the litter doors are back in service.

Buckling occurred in the outer skin of the litter door on four helicopters parked in the Southwest United States desert during the summer. The probable cause of buckling is the thermal mismatch between the Kevlar-49/epoxy skins and the plexiglass window. This window was bonded to the exterior skin. The coefficient of thermal expansion of the plexiglass window is 4.5×10^{-6} in/in/°F, and the coefficient of thermal expansion for the Kevlar/epoxy

skin is near zero. Personnel at this desert facility have taken surface-temperature measurements on aluminum helicopter structures with the same external paint scheme as the composite skins, and their results show that the temperatures typically reach 200°F to 225°F during the summer. The bond between the door structure and window was broken near the buckle on the four doors. The doors were modified and a rubber seal was bonded between the door structure and window to permit relative thermal expansion. Other normal service problems have occurred such as broken windows, bumps, and scratches, all of which were repaired at the operator's repair facilities according to repair instructions received with the kits.

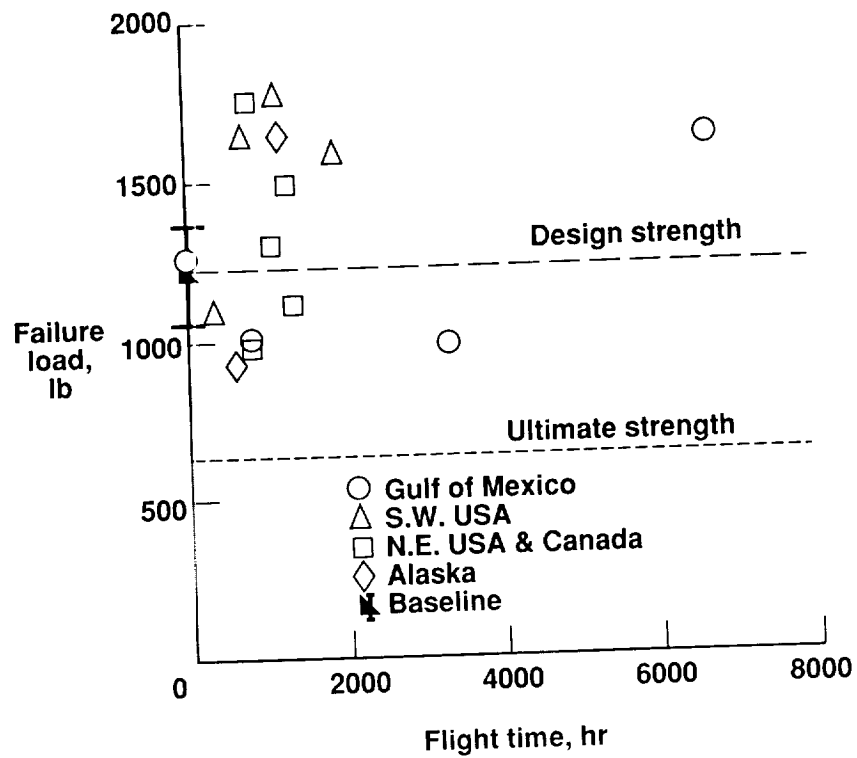
Figure 9. Failure load of litter doors after exposure.

Failure loads (table 1) for 15 litter doors vary from 901 to 1768 lb. These failure loads are the total loads on the door including the hinge reaction from the cabin door. Failure loads as a function of flight hours are shown in figure 9. Each open symbol represents the failure load for a different exposure area. Also shown in figure 9 are two strength requirements, ultimate strength and design strength. The ultimate strength is the usual strength that an aircraft component must meet or exceed at all times. The design strength shown is the strength that an unconditioned component (as-fabricated) must meet or exceed. The design strength is intentionally greater than the ultimate strength and is the product of the ultimate strength and the environmental factor determined from the environmentally conditioned material coupon specimens (ref. 2). This strength is shown for reference only since the components tested are between as-fabricated and fully conditioned. The solid symbol represents the average baseline failure load (reported in ref. 2), which is the average of five components selected at random from the production lot of 45 components. The range of failure loads for the baseline tests is also shown in the figure. All litter doors had failure loads that exceeded the ultimate strength requirement of 635 lb (ref. 2), and nine of the doors had failure loads that exceeded the design strength of 1229 lb. It is acceptable for the failure load of doors that have been environmentally exposed to be below the design strength as long as the load is higher than the ultimate strength. Failure loads do not appear to be a function of exposure time. Initially in the postservice testing (ref. 3),

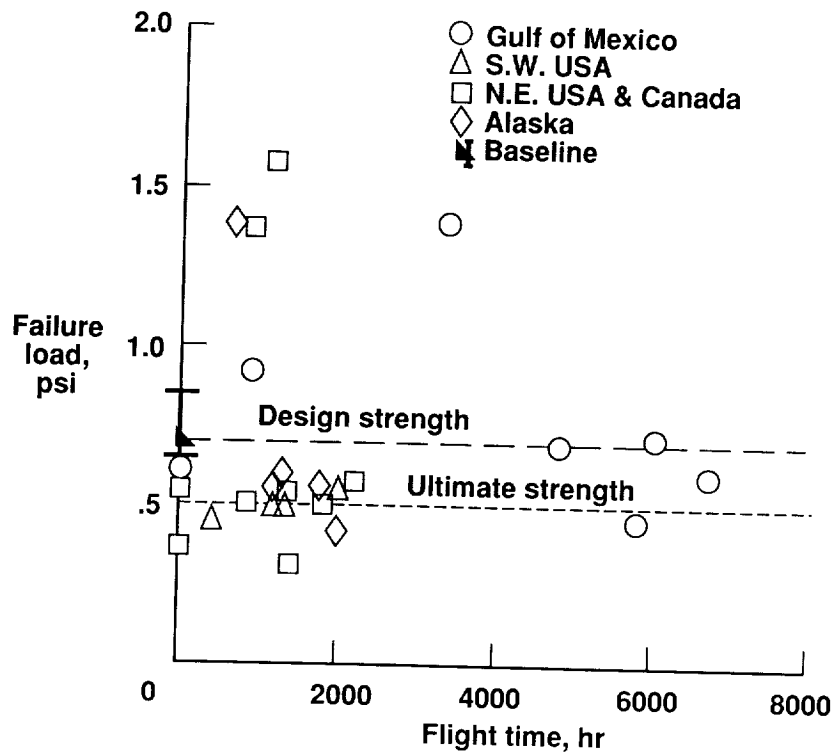
Figure 11. Failure load of baggage doors after exposure.

Failure loads (table 2) for 26 baggage doors vary from 0.32 to 1.57 psi, and service times for the doors vary from 386 to 6750 hours. Failure loads as a function of flight hours are shown in figure 11. Each open symbol represents the failure load for a different exposure area. The solid symbol represents the average baseline strength. These baggage doors are the components that developed large disbands and have been removed from service. Most of the test points represent baggage doors that have some disbond between the core and the outer skin. Twenty-one of the doors had failure loads that were below the design strength of 0.70 psi, and nine doors had failure loads that were below the ultimate strength requirement of 0.50 psi (ref. 2). The stiffness of the baggage door as a function of the flight hours is shown in figure 12. The stiffness was determined by measuring the deflection at the center of the door as the loads were applied. The disbands do not appear to affect the stiffness as much as the strength. The baggage doors that have been tested have accumulated a total of 51 798 hr of flight service.

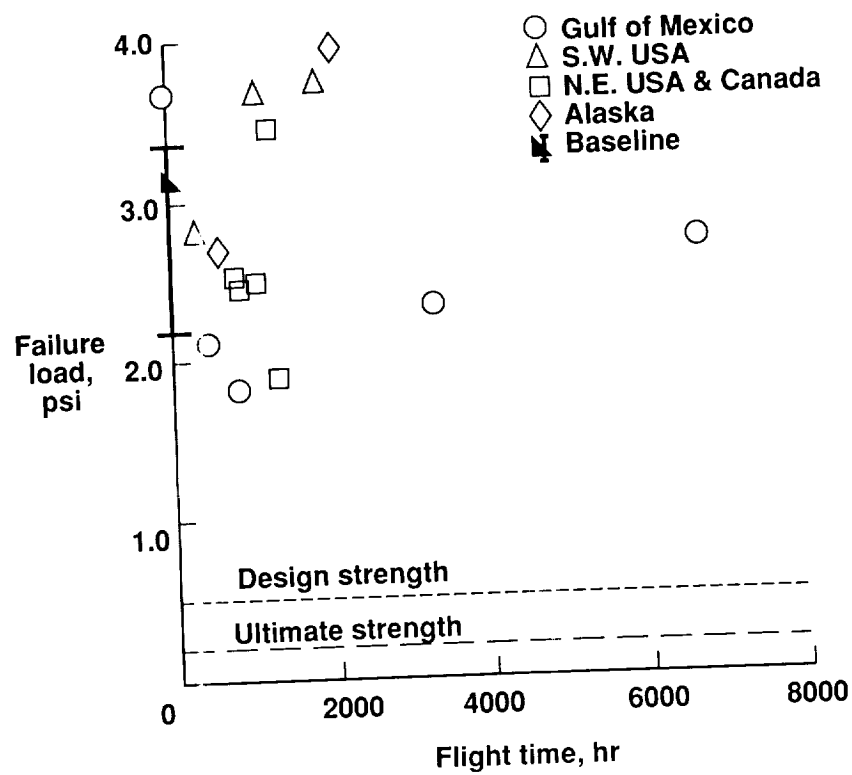
Figure 13. Failure load of forward fairings after exposure.

Failure loads (table 3) for 15 forward fairings vary from 1.80 to 3.93 psi, and service times for these components vary from 386 to 6750 hr. Failure loads as a function of flight hours are shown in figure 13. Each open symbol represents the failure load for

a different exposure area. Failure loads vary from 1.80 to 3.93 psi and exceed the design strength of 0.49 psi (ref. 2) by more than a factor of 3. Failure loads for forward fairings tested to determine the baseline strength (ref. 2) varied from 2.2 to 3.4 psi. Failure loads for 8 of the 15 forward fairings tested are between 2.2 and 3.4 psi. The large scatter in the failure load could be the result of variations in the fabrication process. Considerable variation could result from putting down the single ply of Kevlar fabric (style 281) on a compound contoured surface. The lay-up requires cutting and overlapping the fabric at many places to prevent wrinkling on the surface. The stiffness of the forward fairing as a function of the flight hours is shown in figure 14. The stiffness was calculated using measurements for the deflection of the upper surface at a point 14.5 in. from the aft end as the load was applied. The stiffness of all fairings, except one, exceeded the stiffness of the certification fairings. The fairings that have been tested accumulated a total of 23 730 hr of flight time.

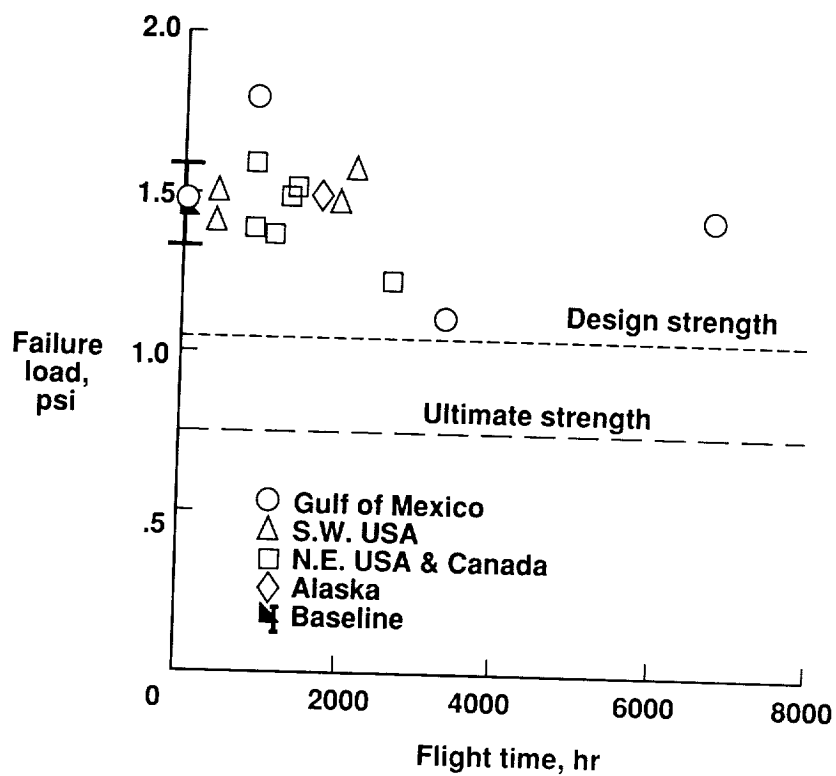
Figure 15. Failure load of vertical fins after exposure.

Failure loads (table 4) for 15 vertical fins vary from 1.12 to 1.80 psi, and service times for these fins vary from 385 to 6750 hr. Failure loads as a function of flight hours are shown in figure 15. All fins exceed the design strength of 1.05 psi. Failure loads for 12 of the 15 fins are between 1.35 and 1.57 psi, which is the range of failure loads for the baseline tests (ref. 2). One fin that was struck by lightning is identified in table 4. The fin was damaged at the top with no damage in the structural box. This fin failed at 1.23 psi with no apparent effect from the lightning strike. The environment does not appear to affect the failure load of the vertical fins. The stiffness of the vertical fin as a function of flight time is shown in figure 16. Stiffness was calculated using measurements for the tip deflection as the simulated aerodynamic load was applied. The certification deflection data for the fin are not available. The vertical fins that have been tested have accumulated 26 139 flight hours.

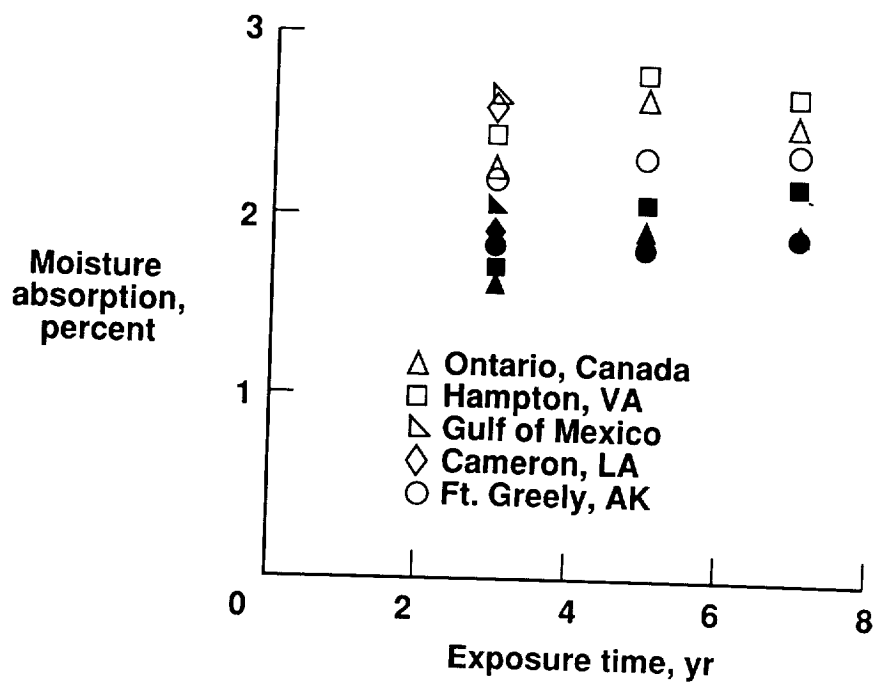
Figure 20. Moisture absorption of Kevlar-49/F-185 composite material. Solid symbols represent unpainted specimens.

Moisture absorption data for the Kevlar-49/F-185 material are shown in figure 20. This figure indicates that painted specimens absorb more moisture than the unpainted specimens. Actually, the painted specimens absorb up to 0.63 percent (average) more moisture than the unpainted specimens. Moisture absorption data for the Kevlar-49/LRF-277 material are shown in figure 21. The trend in this material

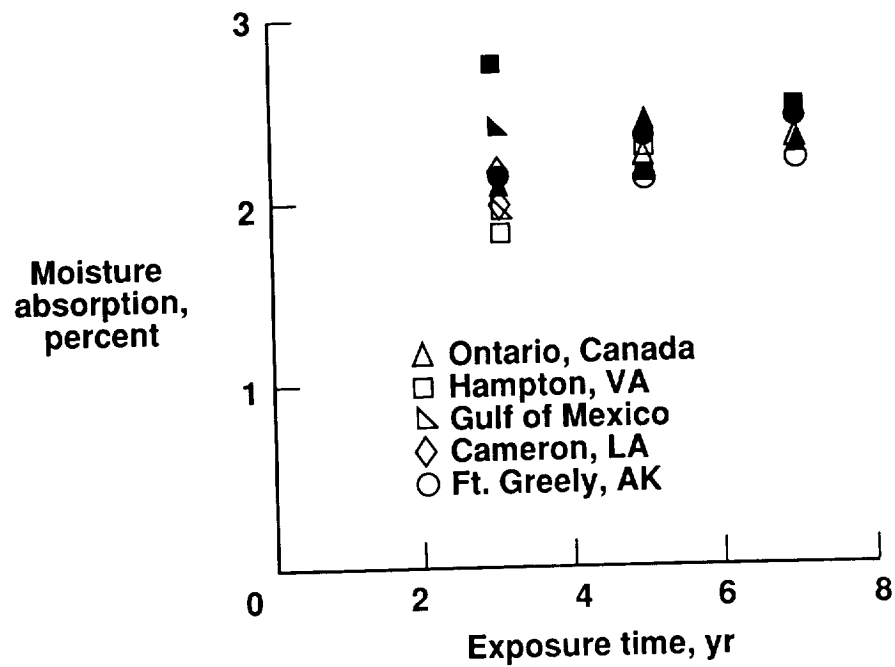
Figure 21. Moisture absorption of Kevlar-49/LRF-277 composite material. Solid symbols represent unpainted specimens.

is the opposite from the other two Kevlar materials in this program. For the Kevlar-49/LRF-277 material the unpainted specimens absorb more moisture than the painted specimens. By the seventh year of exposure the unpainted specimens are approaching an equilibrium condition of 2.3 percent moisture absorption.

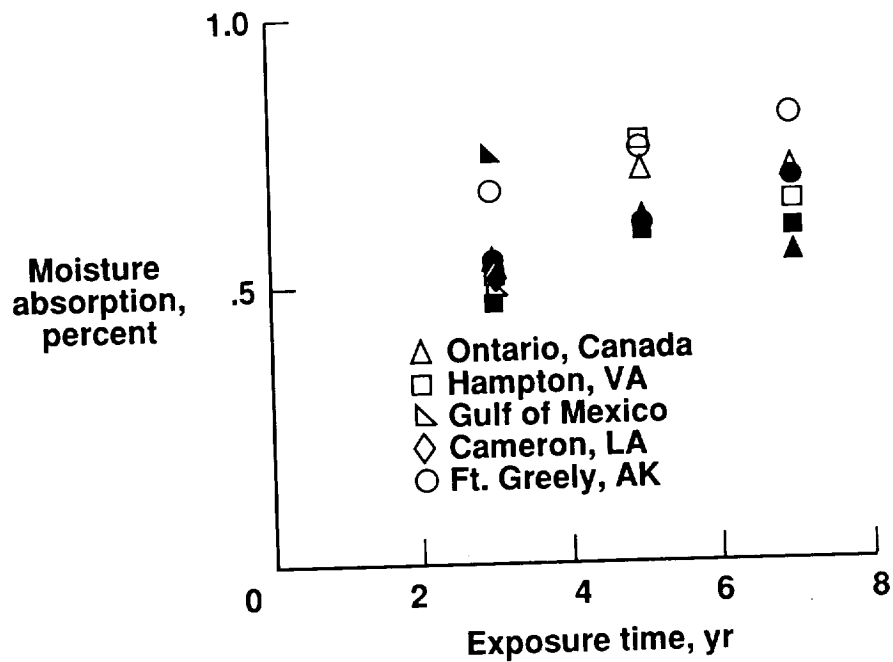
Figure 22. Moisture absorption of T-300/E-788 graphite/epoxy composite material. Solid symbols represent unpainted specimens.

Moisture absorption data for the T-300/E-788 graphite/epoxy material are shown in figure 22. The 0.74-percent absorption for a 3-year exposure at the Gulf of Mexico does appear high. There is no method to determine if this high moisture absorption would continue in the Gulf of Mexico since the rack was destroyed before the removal of specimens after 5 years of exposure. No trend is evident after 3 years of exposure. After 5 and 7 years of exposure the painted specimens absorbed approximately 0.10 percent more moisture than the unpainted specimens, the same trend followed by two of the Kevlar/epoxy systems. Kevlar-49/epoxy materials absorb four to five times more moisture than graphite/epoxy materials because the Kevlar fibers absorb moisture. The average values, for each material, compare well with published values for other Kevlar/epoxy and graphite/epoxy systems (ref. 1).

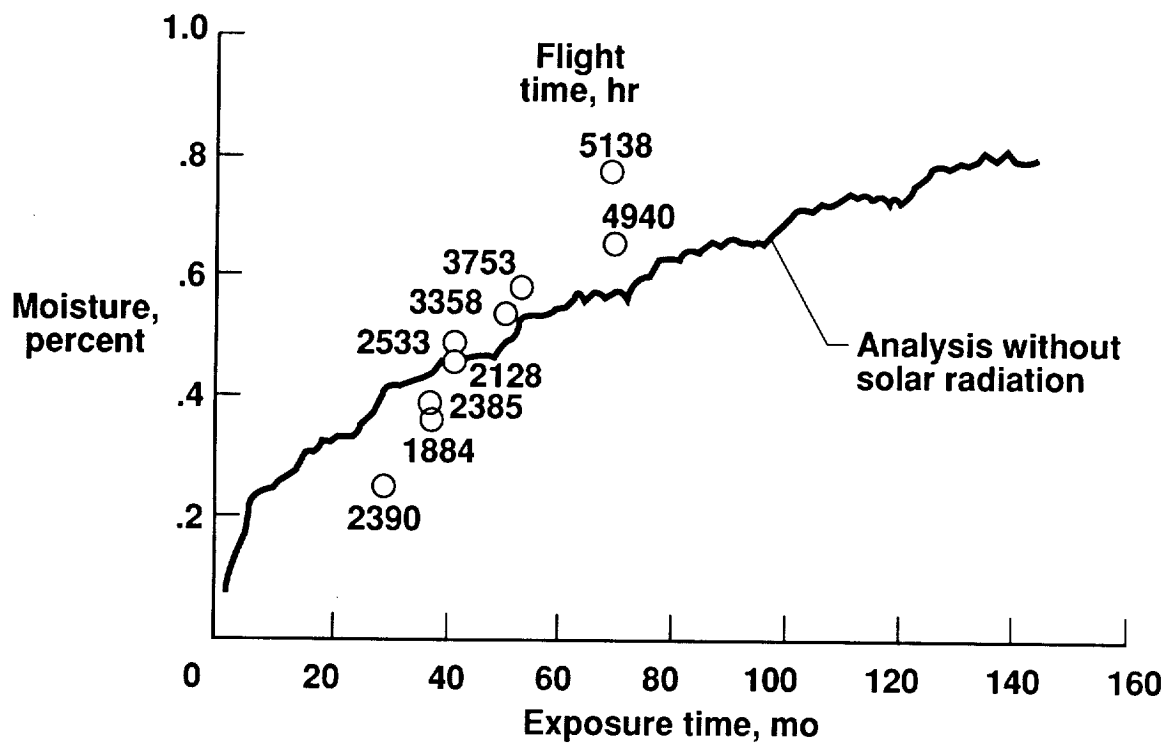
Figure 31. Measured and predicted moisture content for S-76 tail rotor spars exposed at Lake Charles, Louisiana.

A predicted moisture-time profile (ref. 6) for the tail rotor spars (ref. 5) operating in the Louisiana Gulf Coast region is shown in figure 31. Weather data from Lake Charles, Louisiana, were used in predicting the absorbed moisture. Measured moisture values (table 7) are shown in figure 31 on a plot of percent moisture as a function of exposure time. As can be seen in figure 31, the measured moisture values are below the predicted moisture values for the low exposure time (30-40 months), whereas the measured moisture values are for an exposure time of 70 months higher than the predicted values.
